STRUCTURE CONDITION REPORT

BARGE CANAL FAIRPORT-LOCKPORT

MATERIALS BUREAU

STRUCTURE CONDITION REPORT
BARGE CANAL - WESTERN SECTION
FAIRPORT TO LOCKPORT

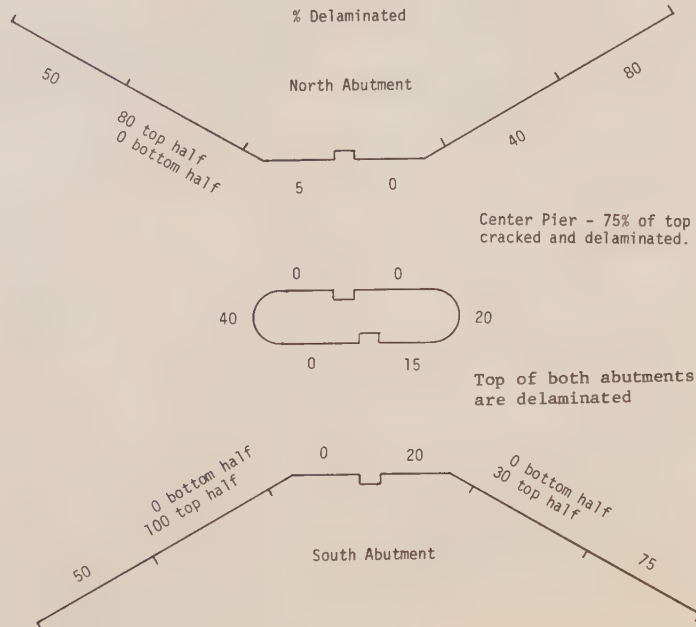
Looking West
Brockport Guard Gate

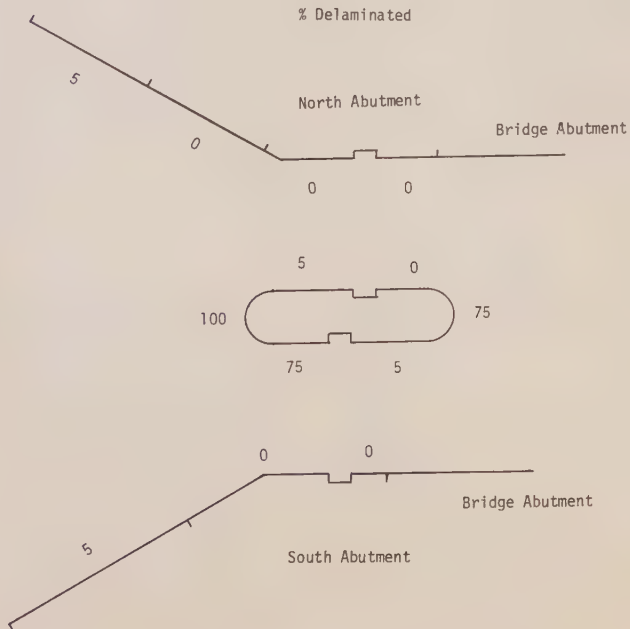
Looking East
Medina Guard Gate

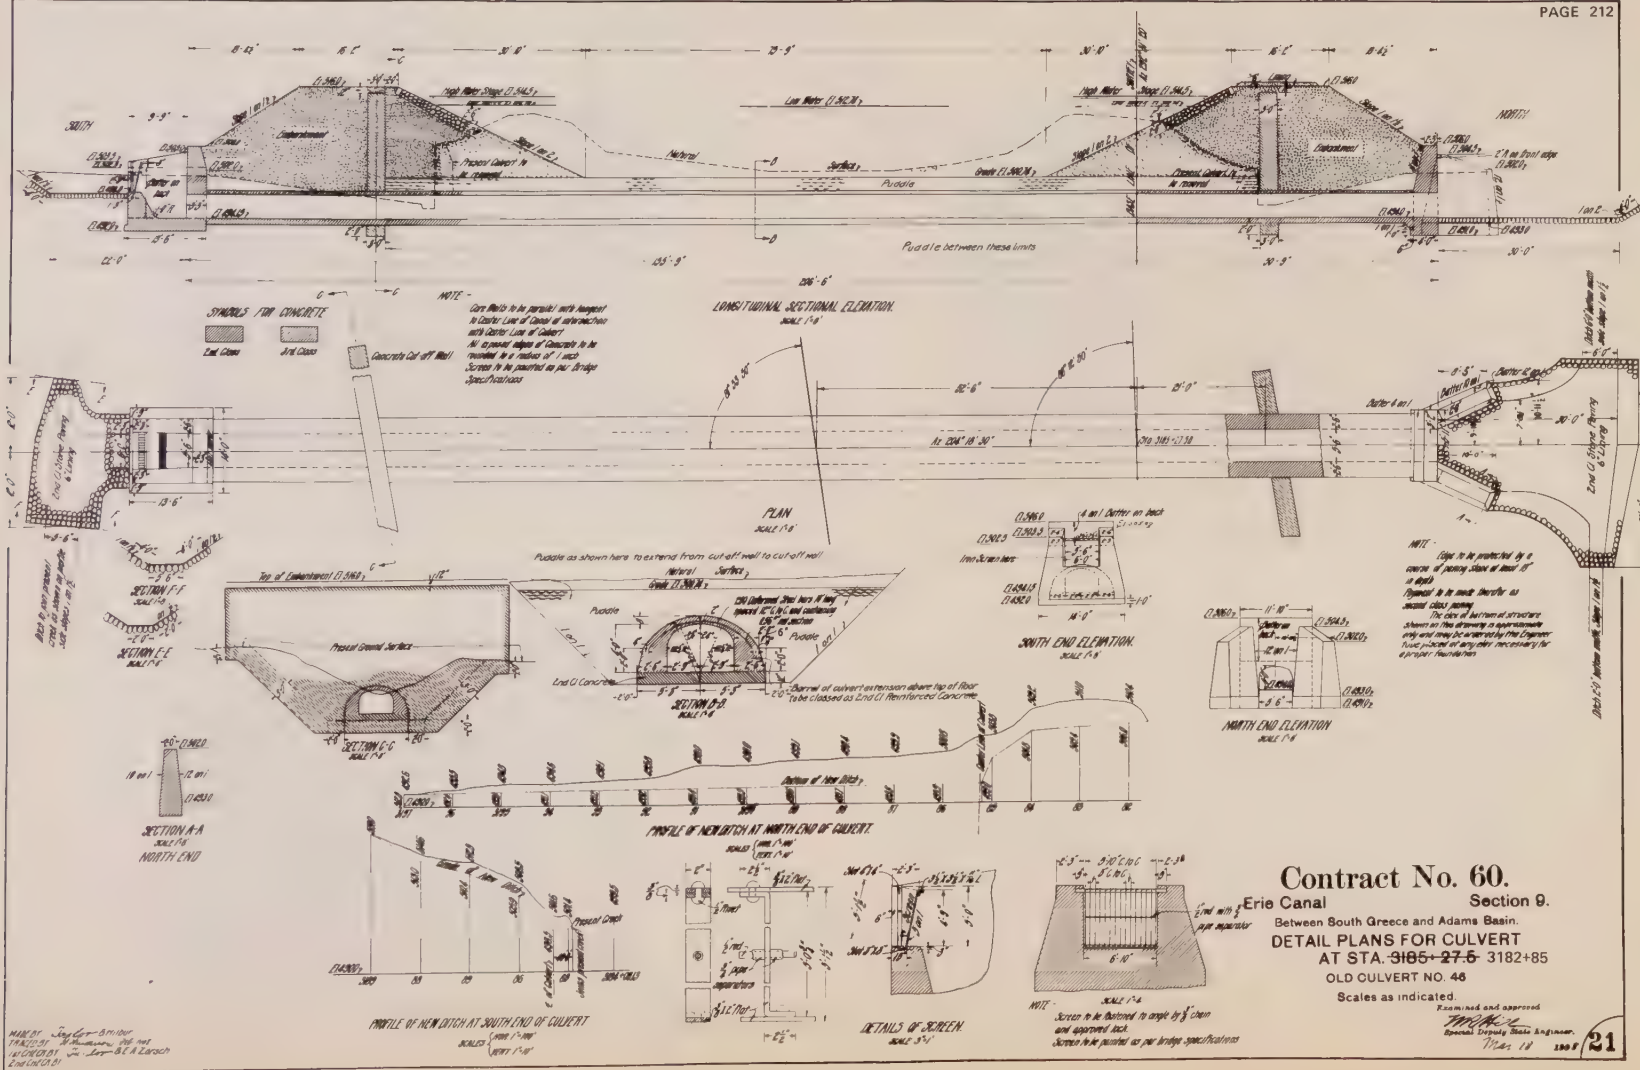
Headwall and left wingwall in good condition. Right wingwall had a lot of surface cracks and efflorescence.

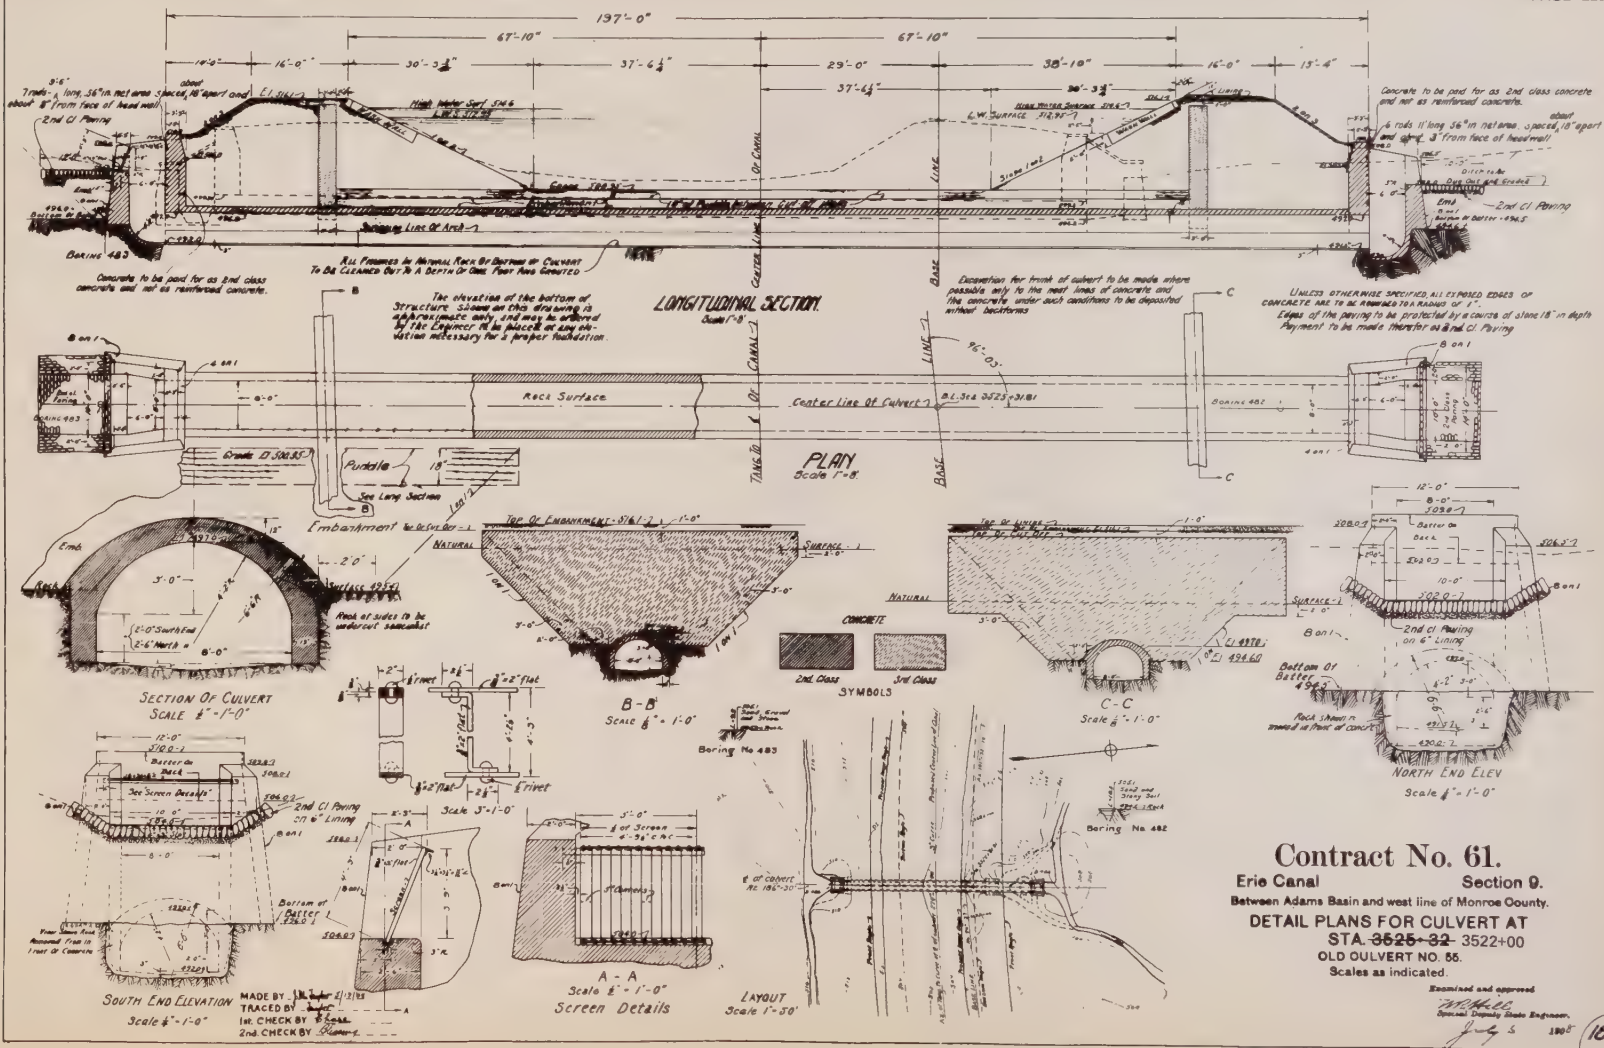
Headwall and wingwalls in good condition.
10" and 4" syphon.

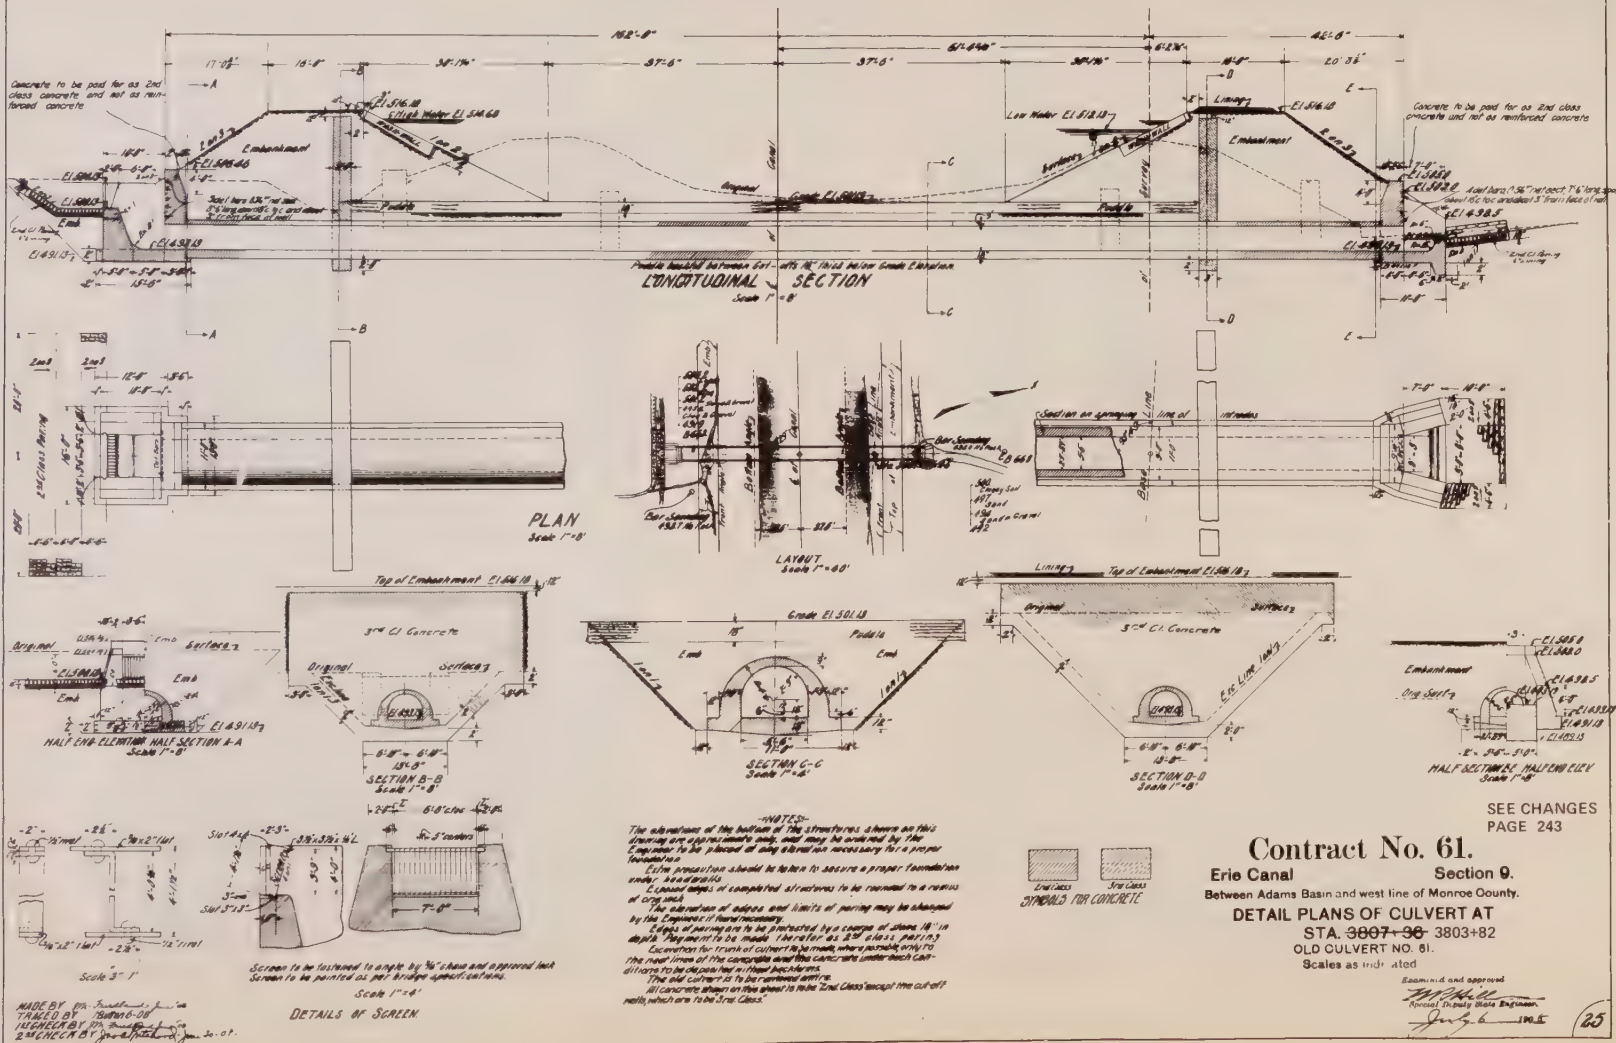
Headwall and wingwalls in fair condition, 1-2" deep scaling. 2 syphons, 10" syphon active.

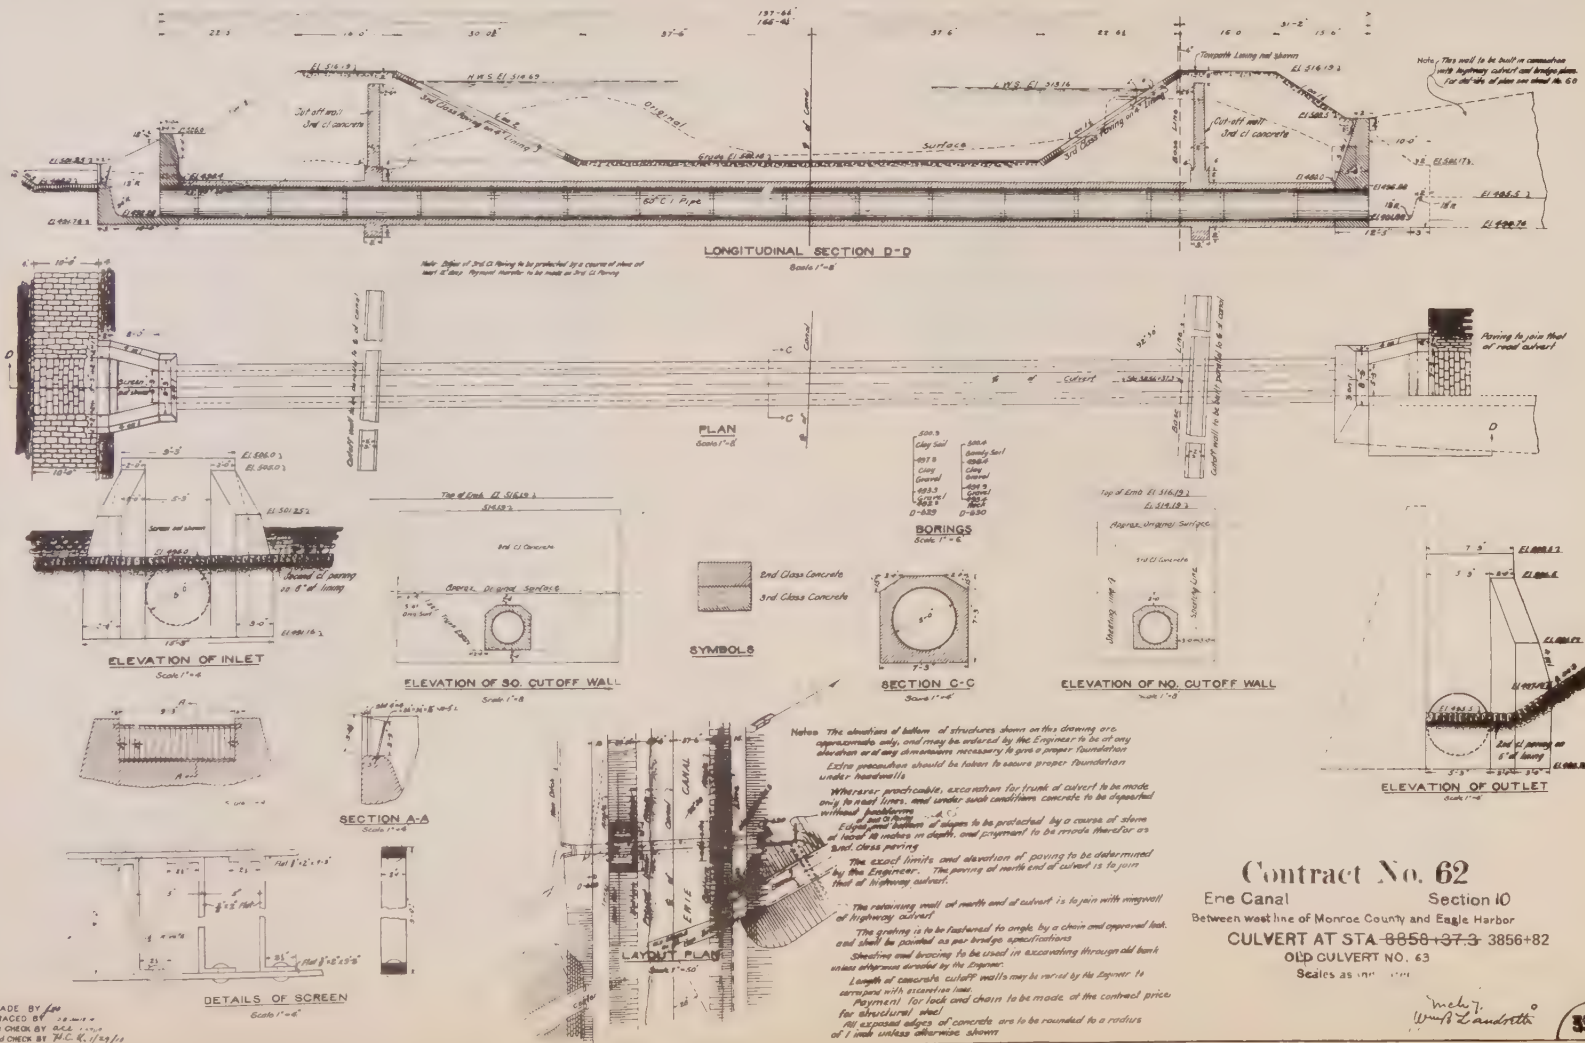
Headwall and wingwalls in poor condition. 4" deep
scaling on headwall and much deeper on wingwalls.

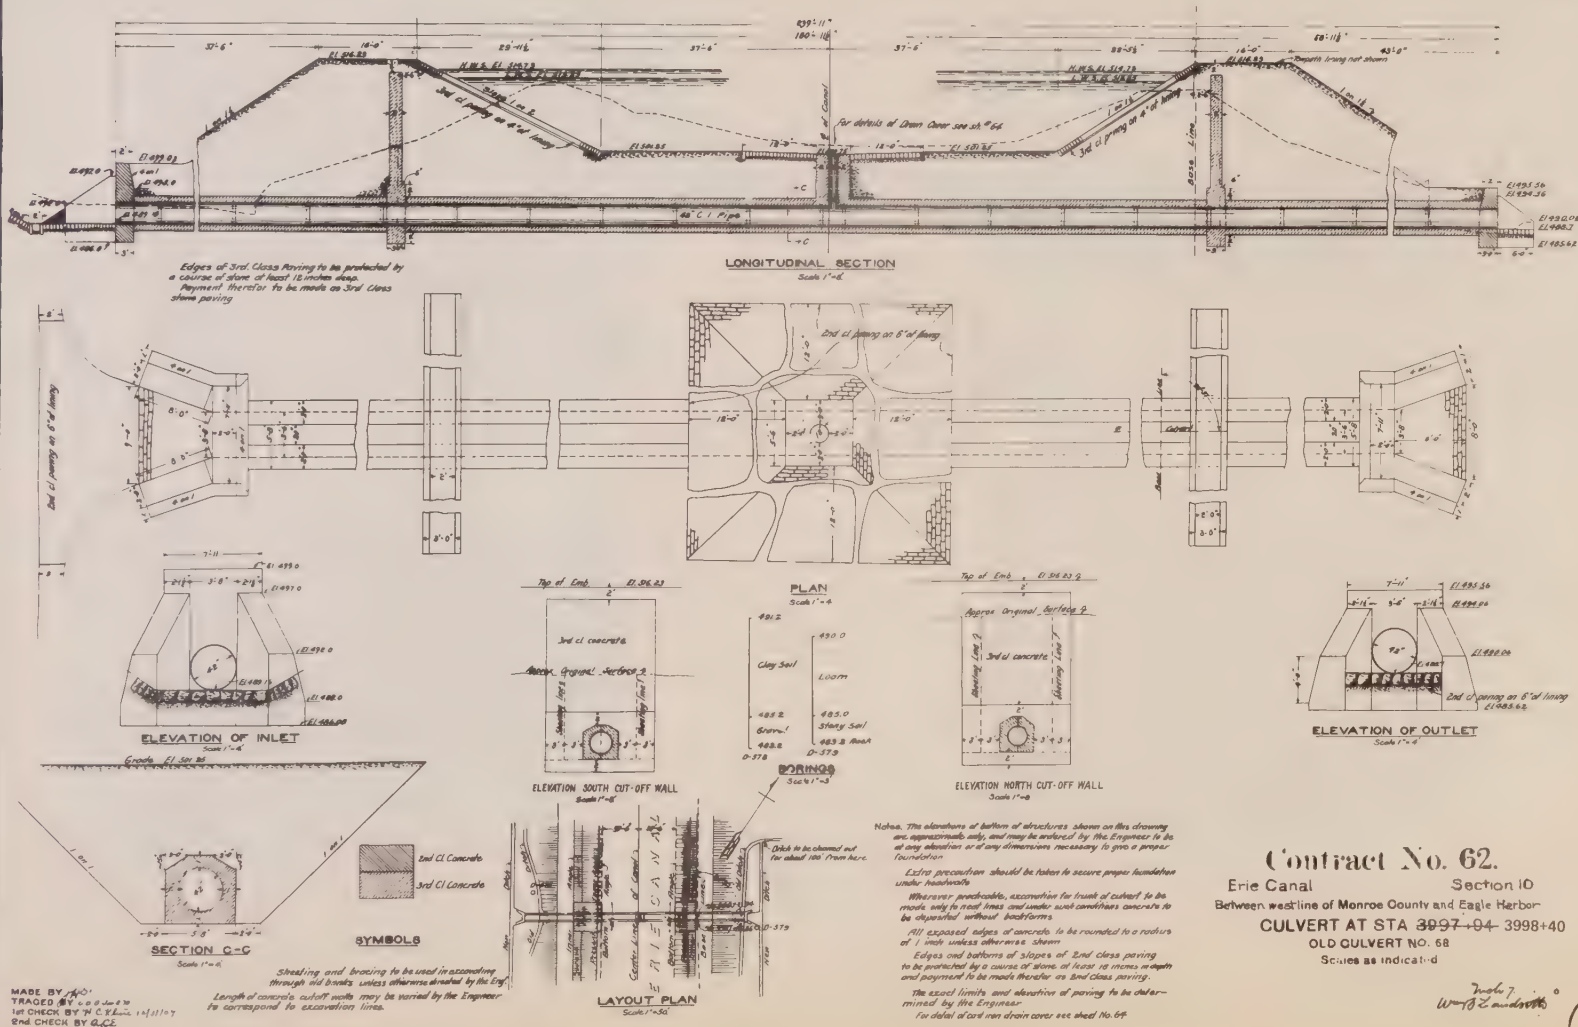
Water seemed to be coming out of rock and brush covered embankment next to left wingwall. Water level was dropped 6" by cleaning out channel. Small brook could then be seen coming out through rocks. 1' deep silt where brook meets culvert stream. Most brook water is not from canal.

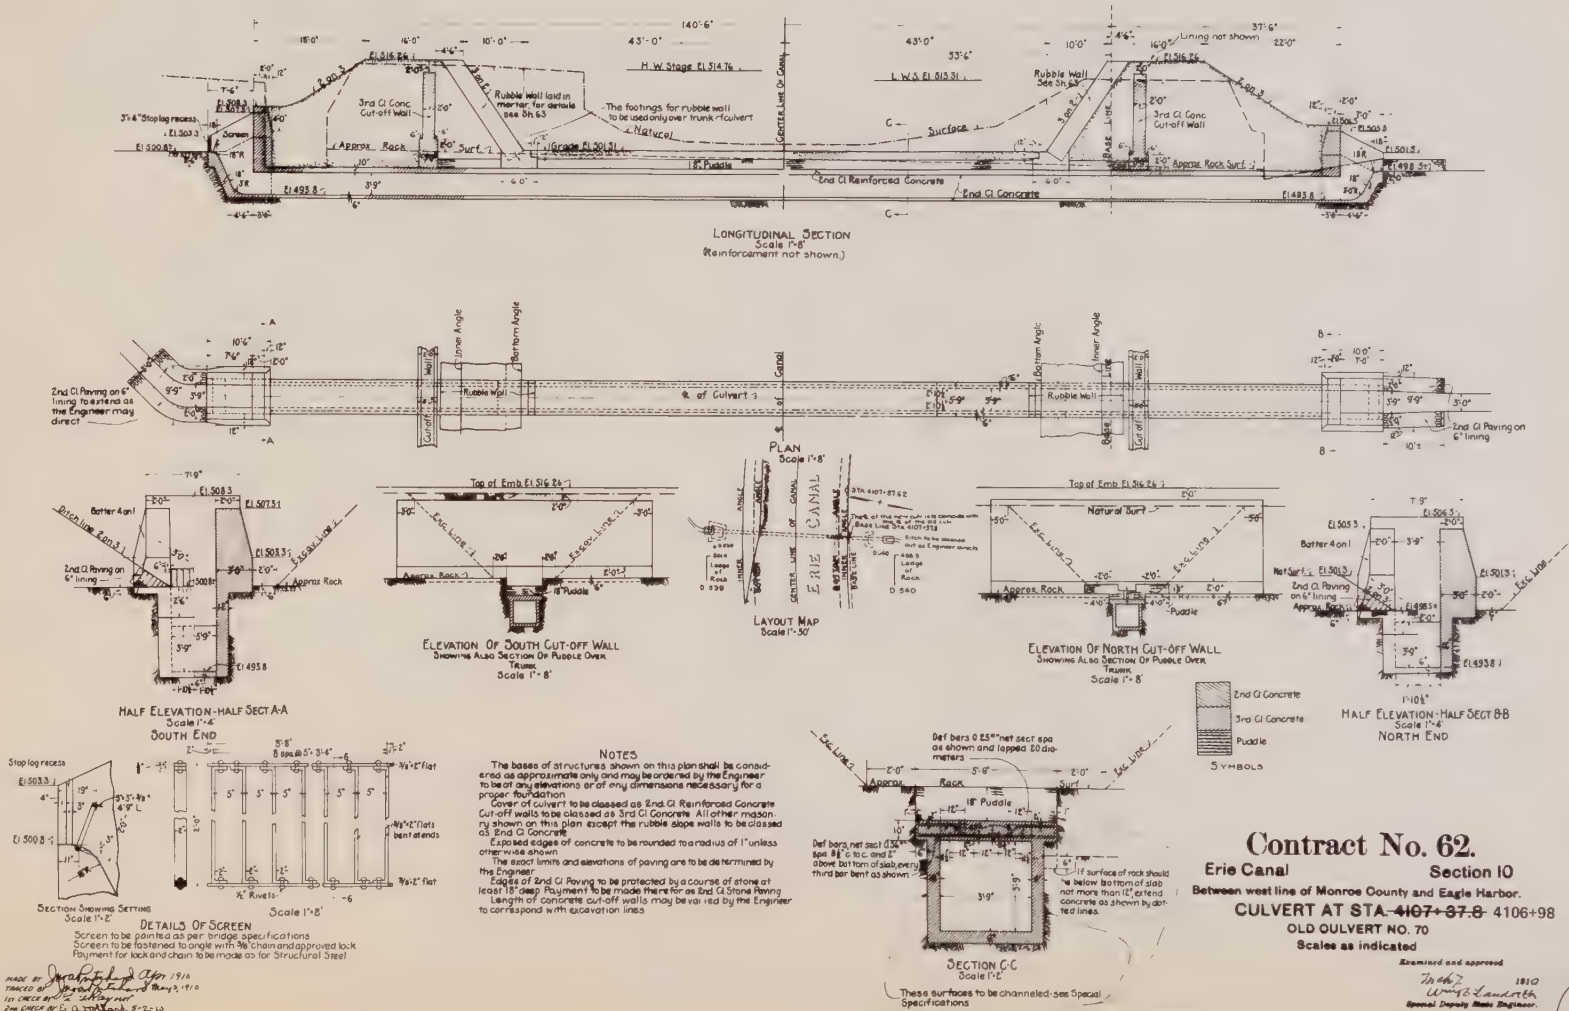
Headwall and left wingwall in good condition. Right wingwall in fair to good condition with low end partially scaled away. 1 active syphon.

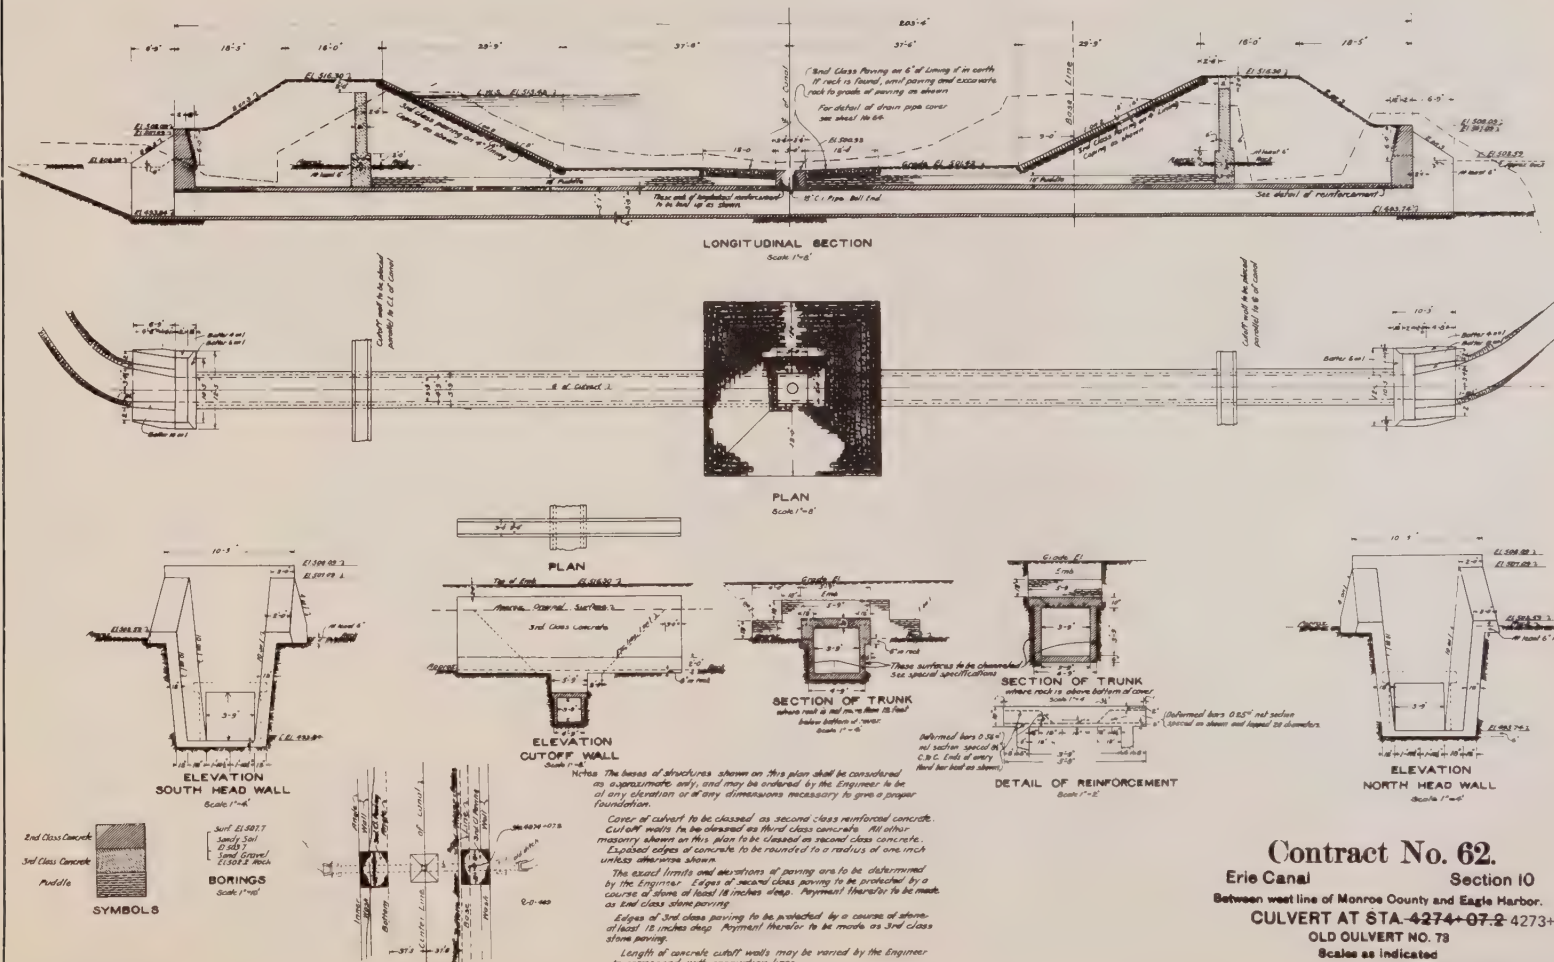
Exit
Headwall and wingwalls in good condition.
Culvert well filled with debris.

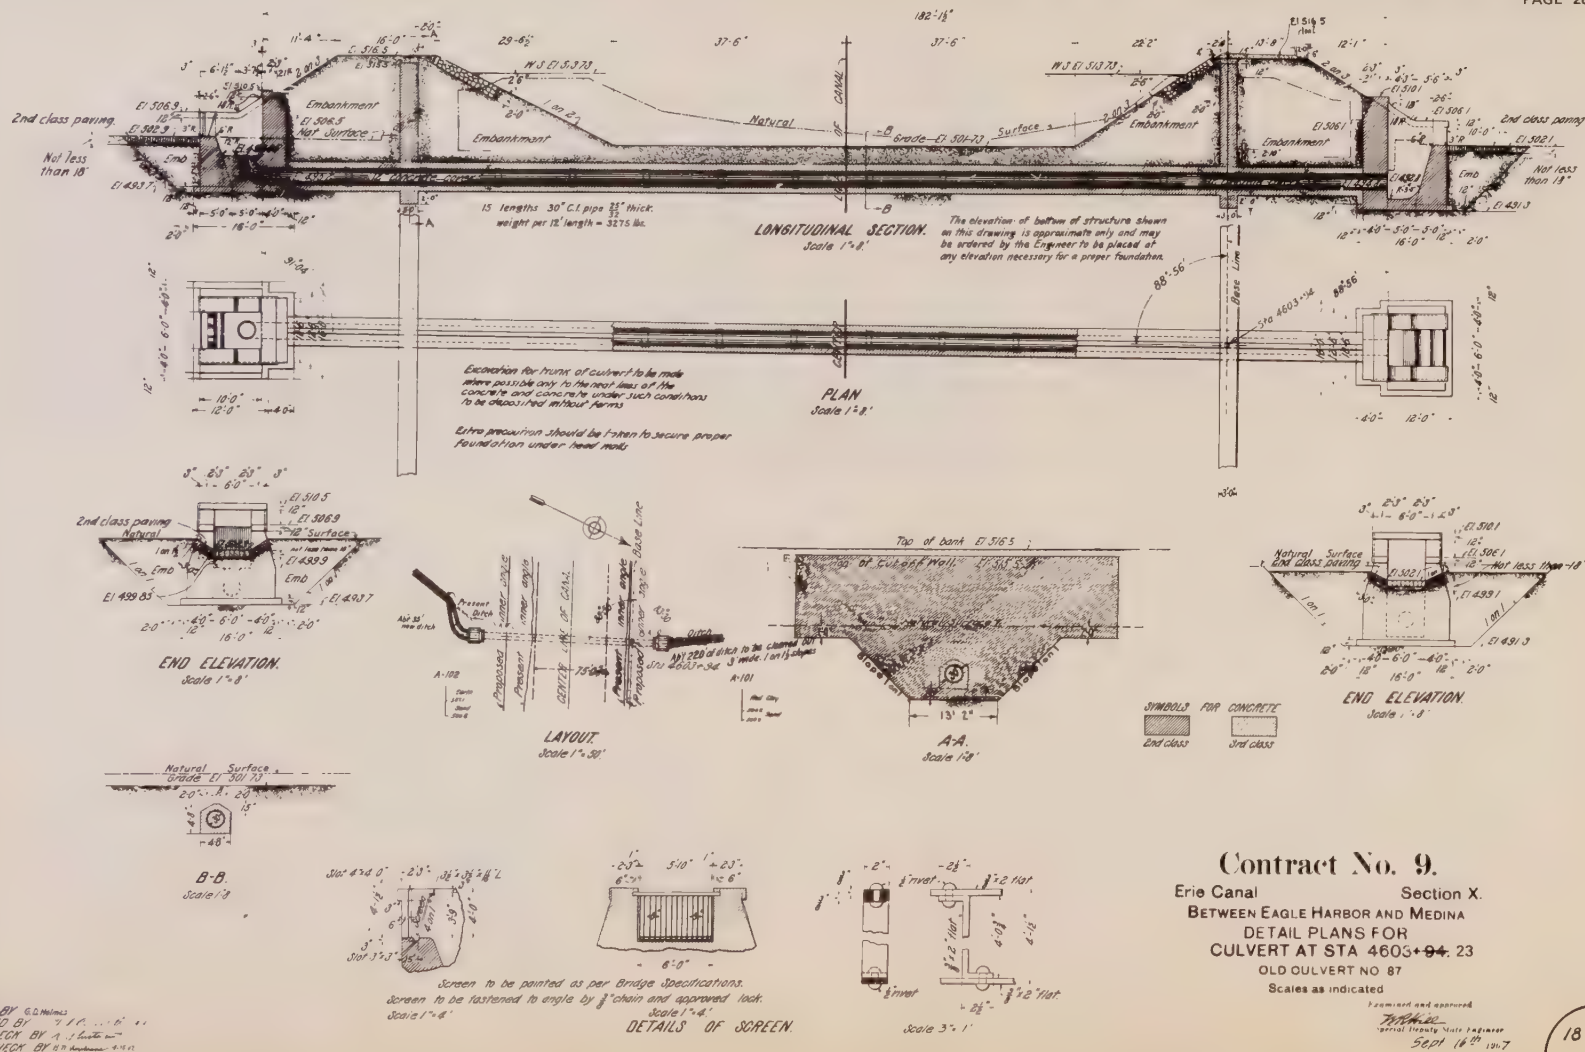
Headwall in good condition. This is not a dive culvert. The drainage channel was filled with vegetation.

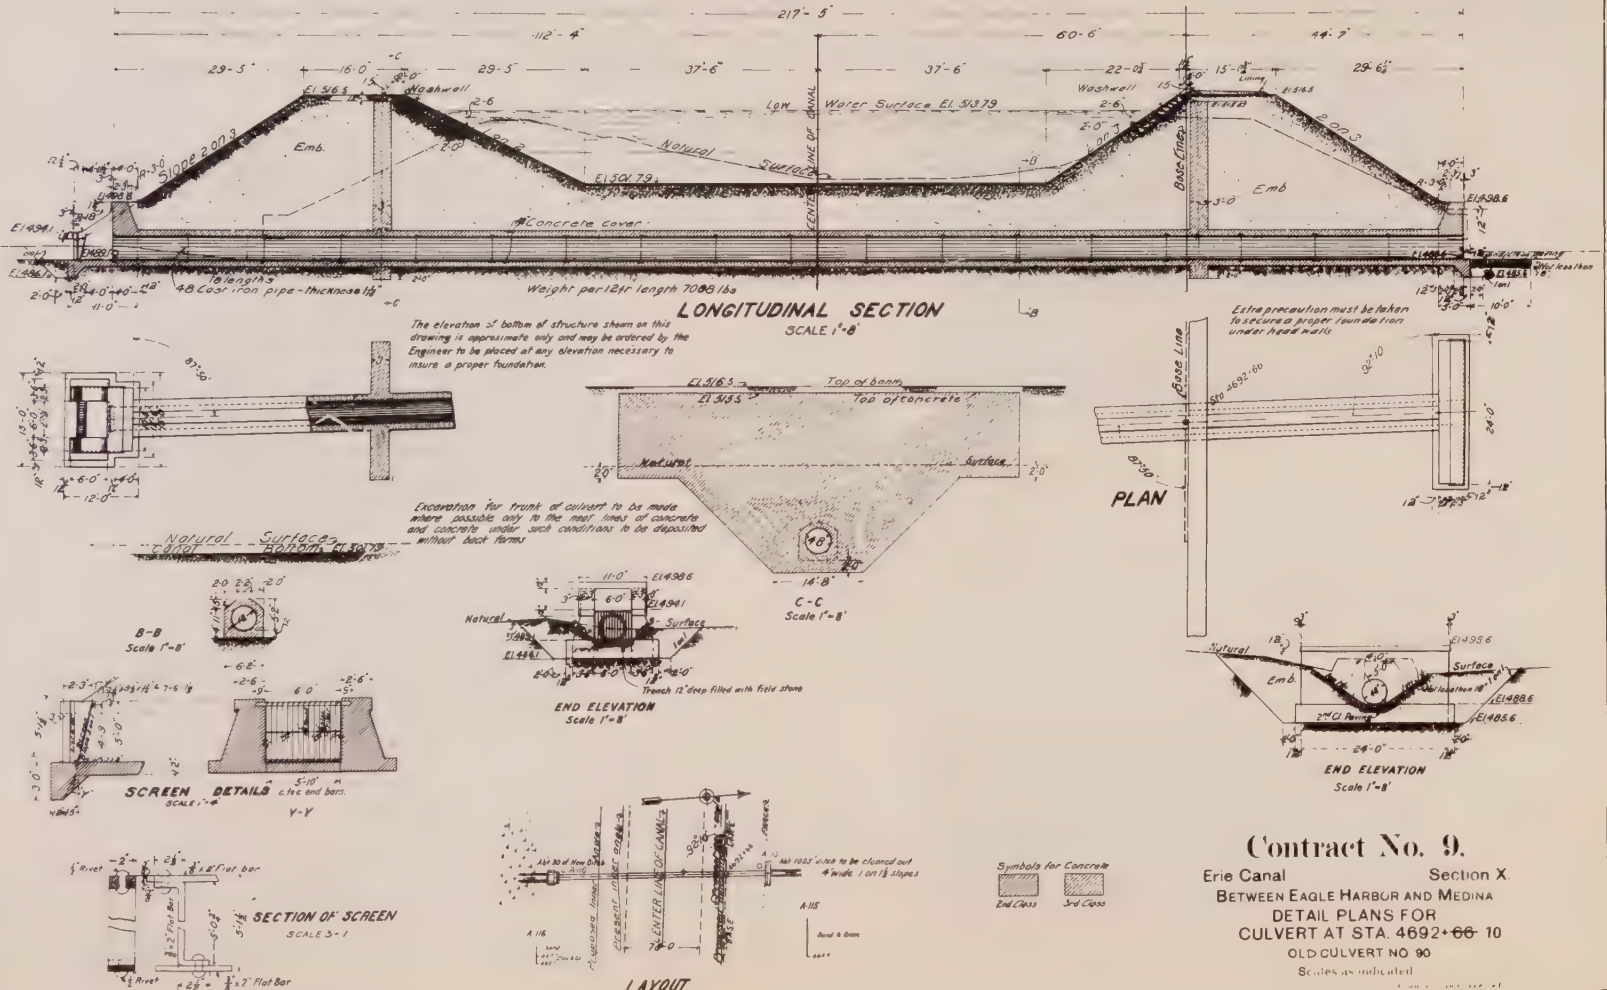
Upper portion of headwall in good condition. Lower portion near water line had a 6' long, 1' wide by 8" deep horizontal scaled area. Wingwalls in poor condition with many cracks and deep scaling at the water line. Culvert well had been fenced off with railing, possibly to keep cows out.

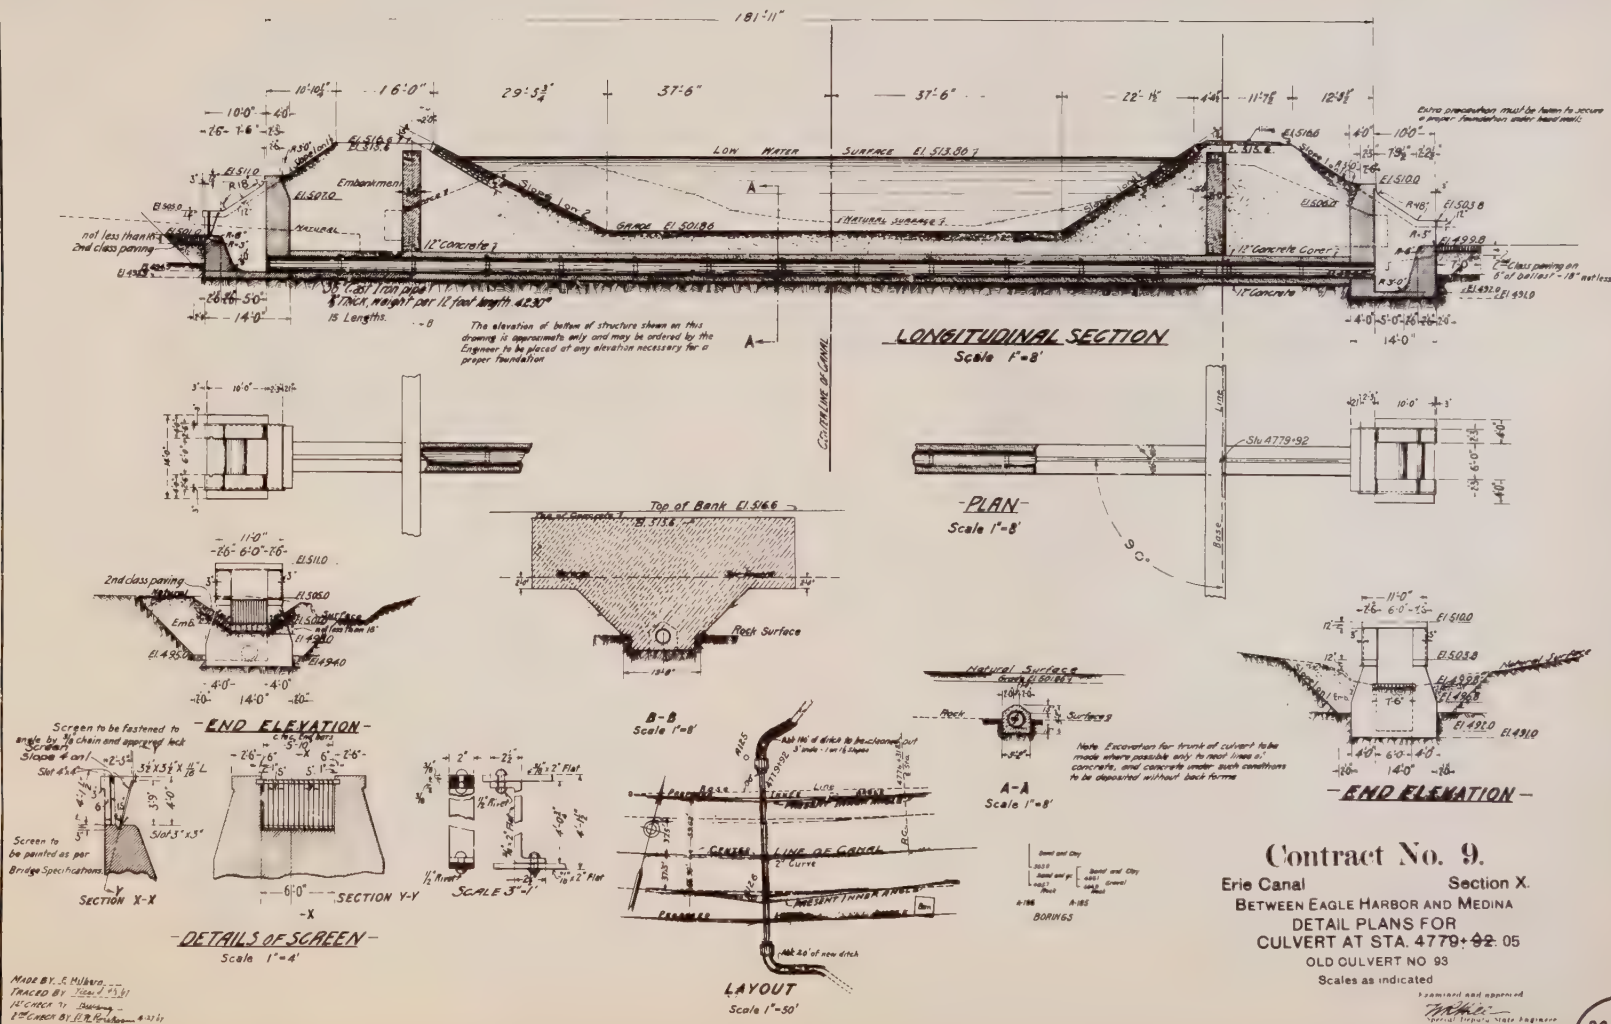
Headwall in fair condition due to many efflorescent covered cracks. Wingwalls were in poor condition with many cracks. About 1/3 of left wingwall has disappeared.

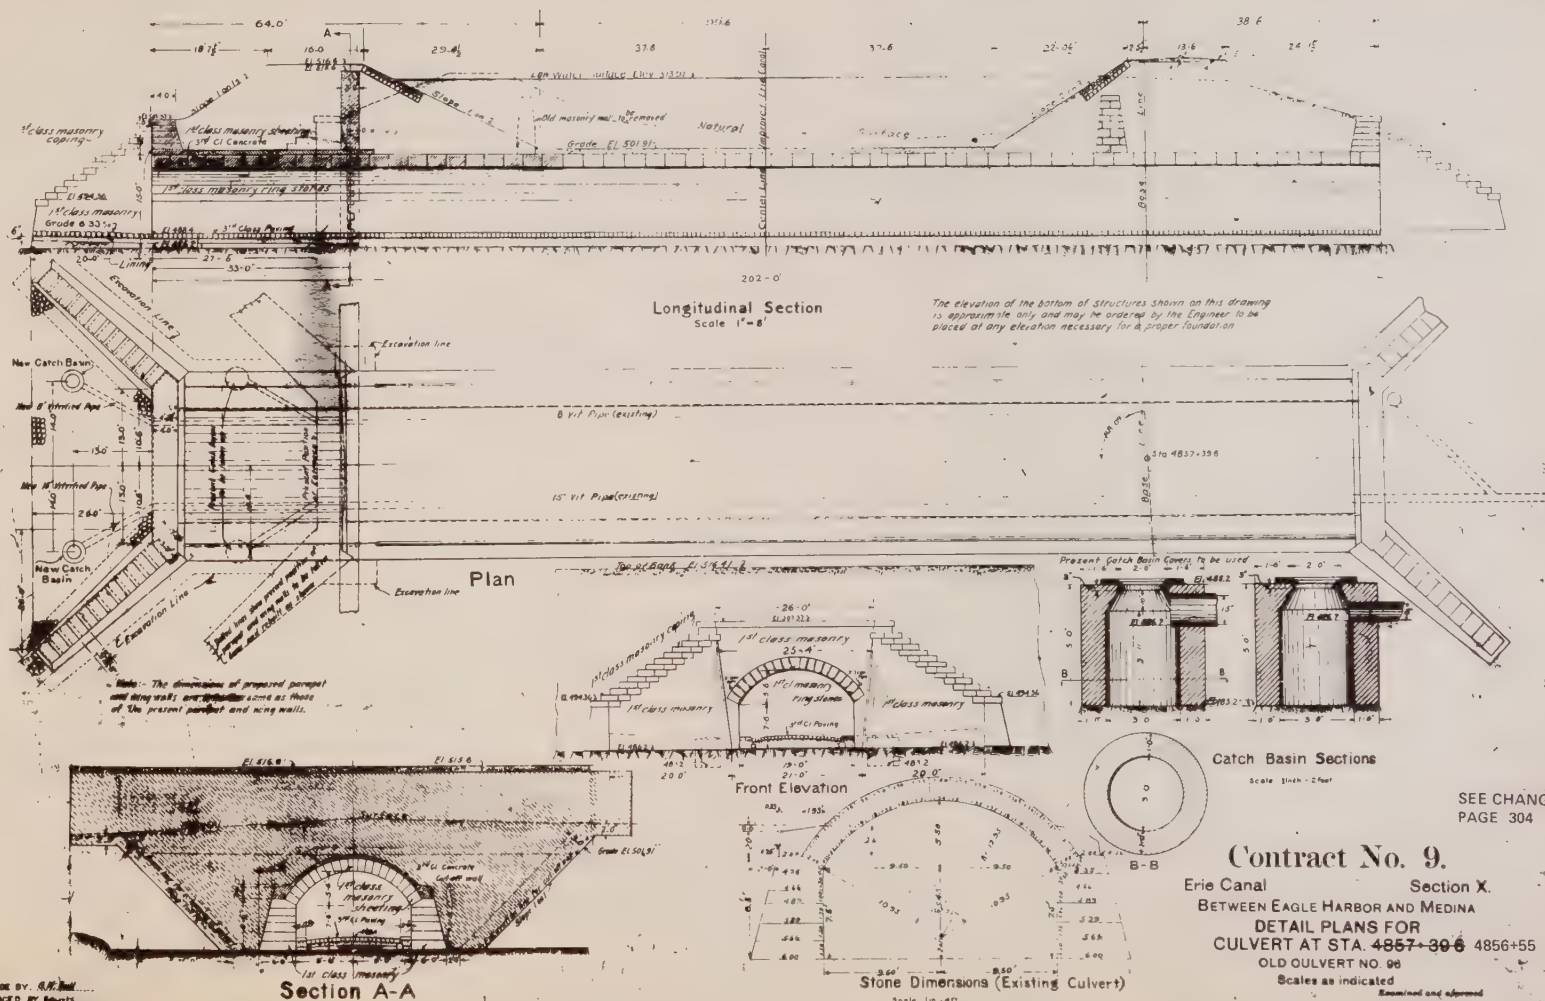
Leak Hole Found About 20' West of Fence
Clay only partially plugged hole.

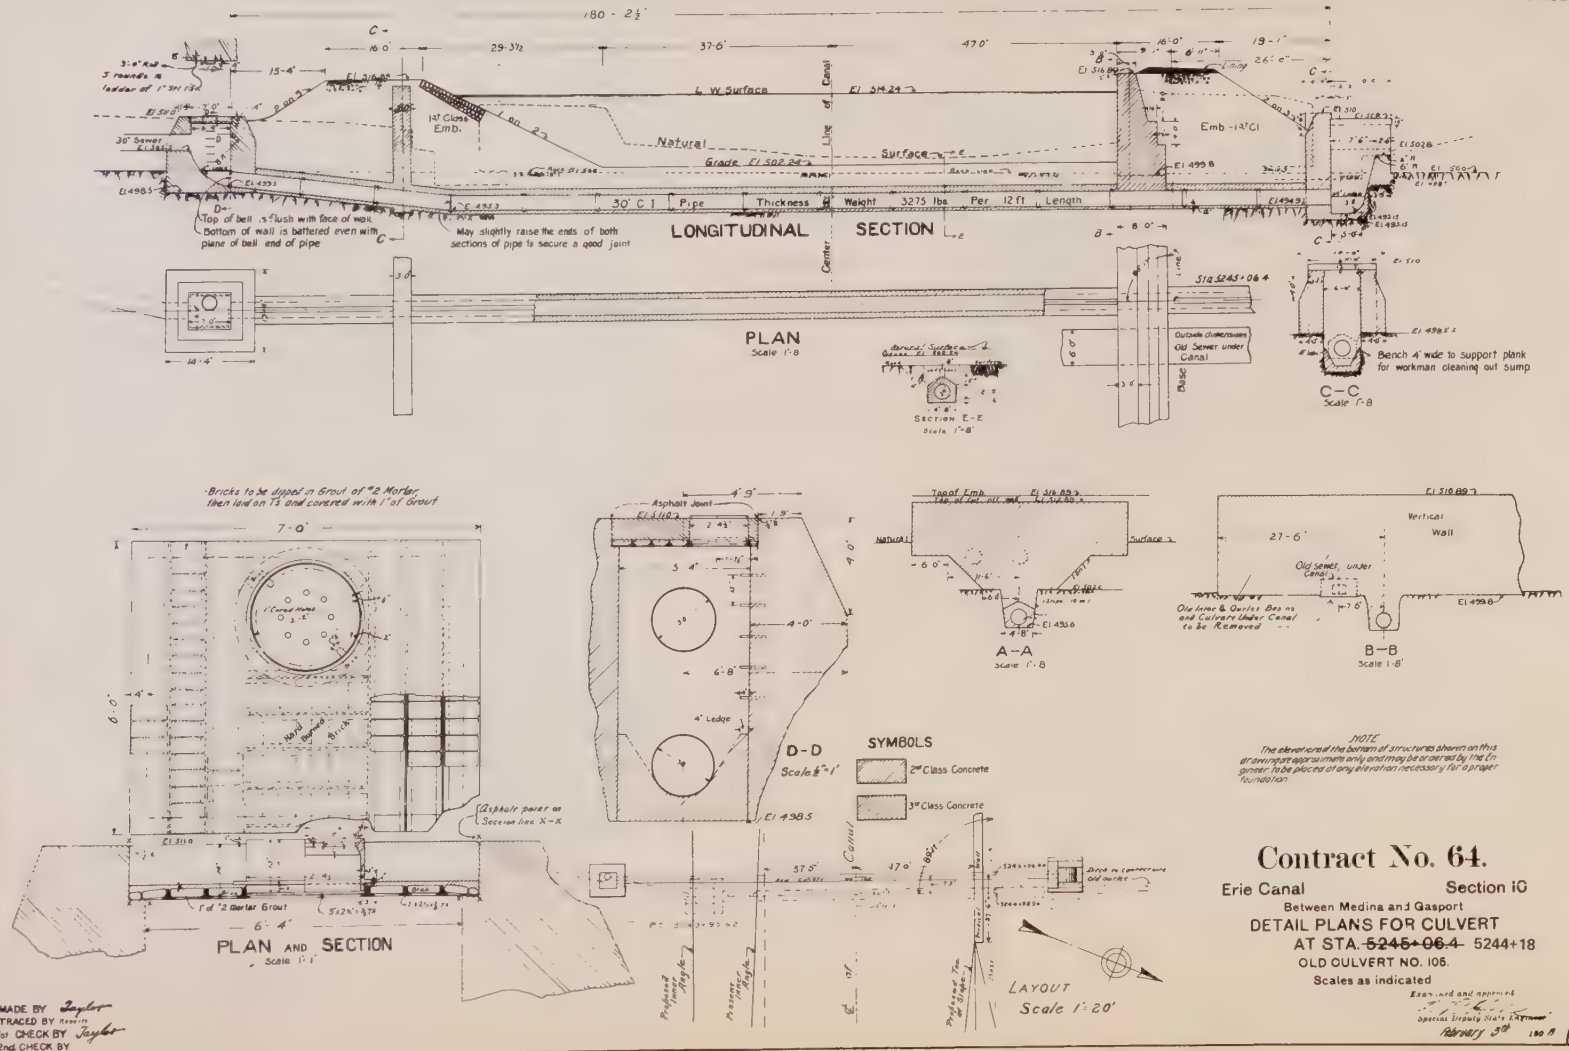
Headwall and wingwalls in good condition. Note culvert well covered with planks.

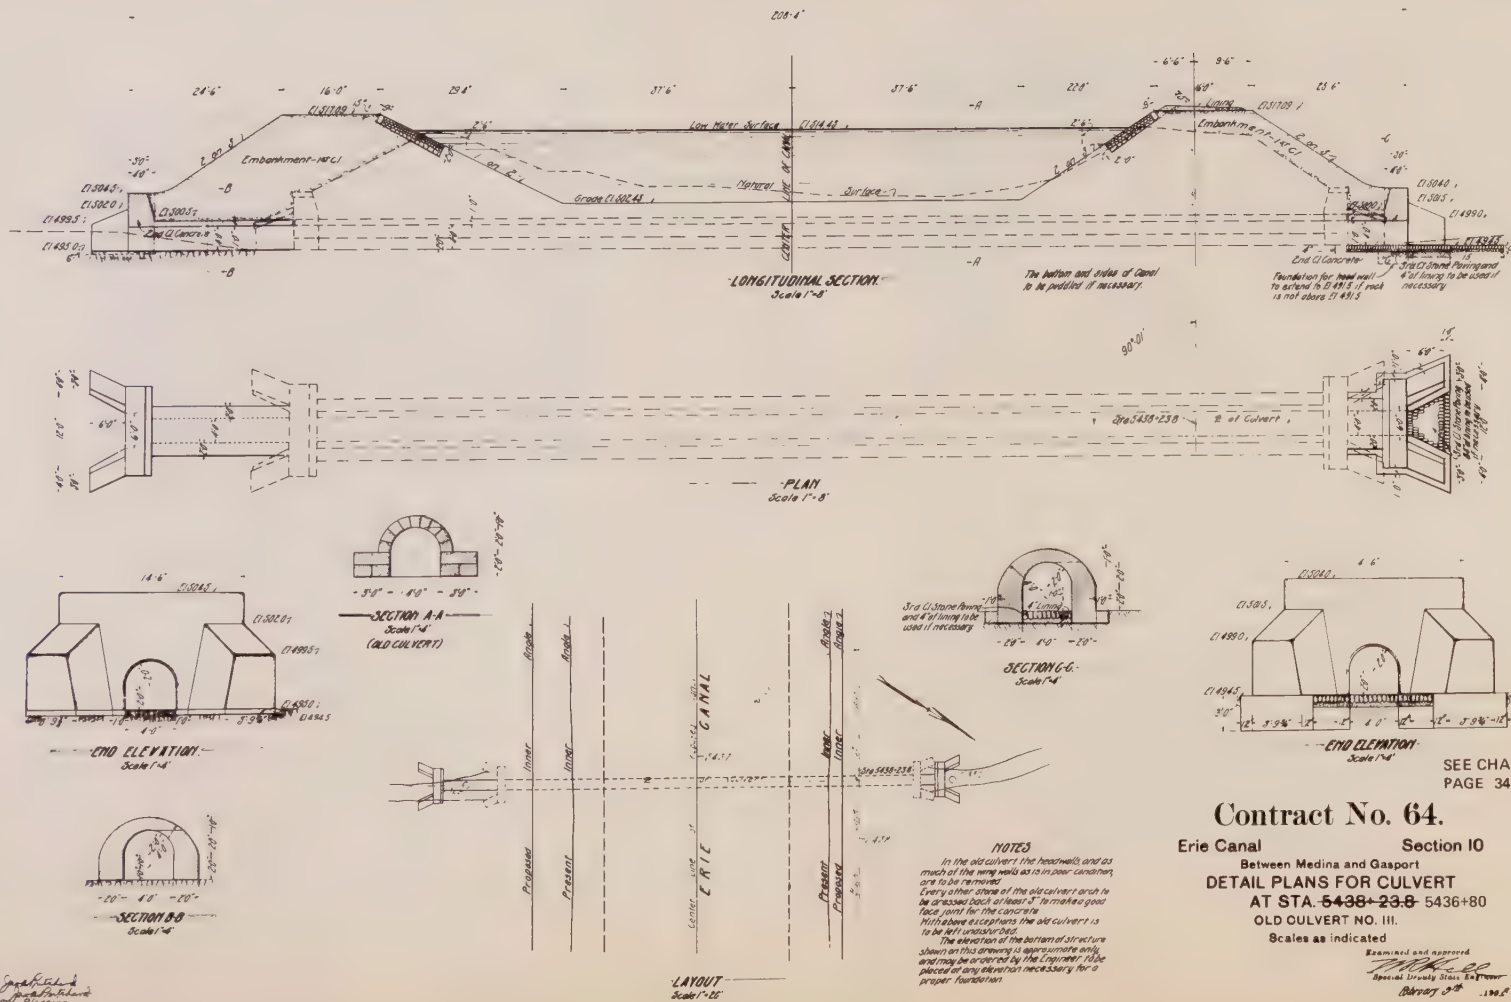
Top section of headwall and most of wingwalls in good condition. Bottom section of headwall cracked and scaled. Ends of wingwalls cracked, scaled and delaminated.
